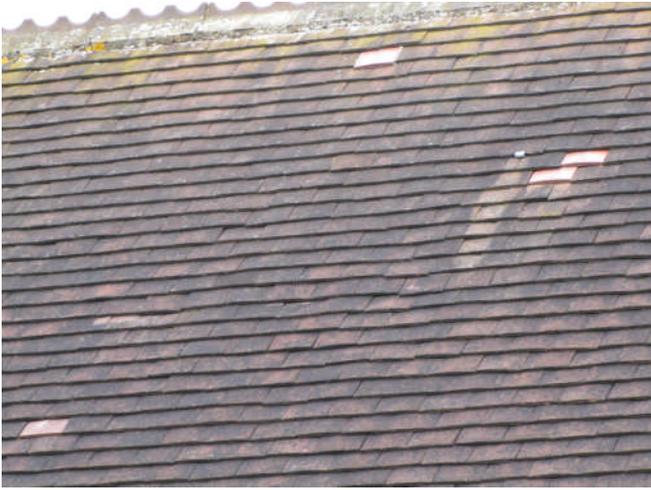
5. Several replacement tiles to the front slope.

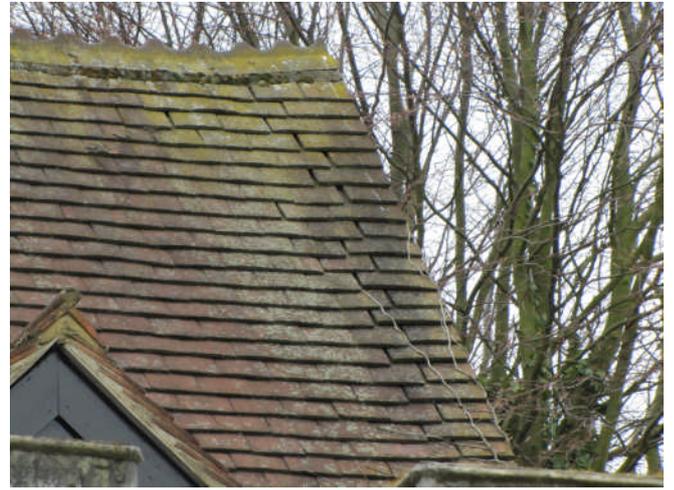
6. Separation of tile courses, near to the left hand verge. (Seen from the rear.)

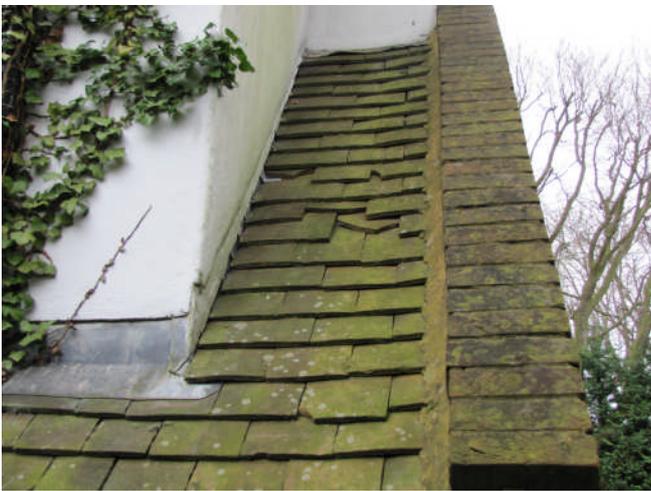
7. Damaged tiles on the inglenook surfaces.

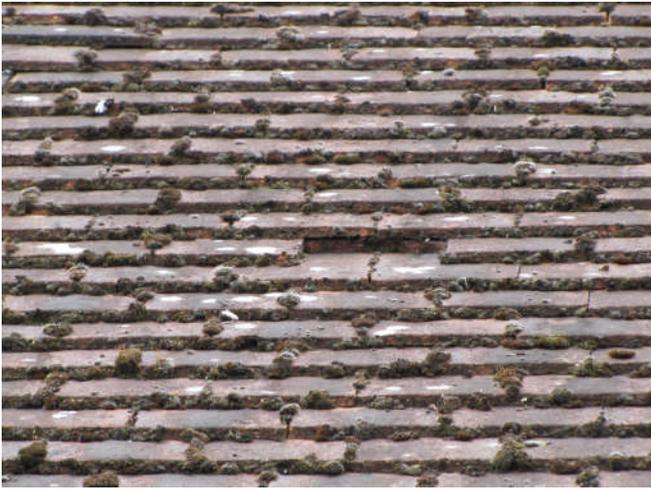
11. Missing tile on the left hand slope.

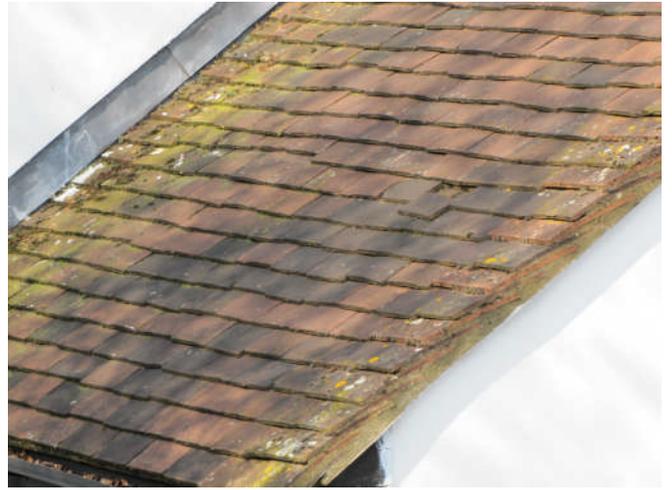
12. Broken tile on the right hand (pediment) slope.

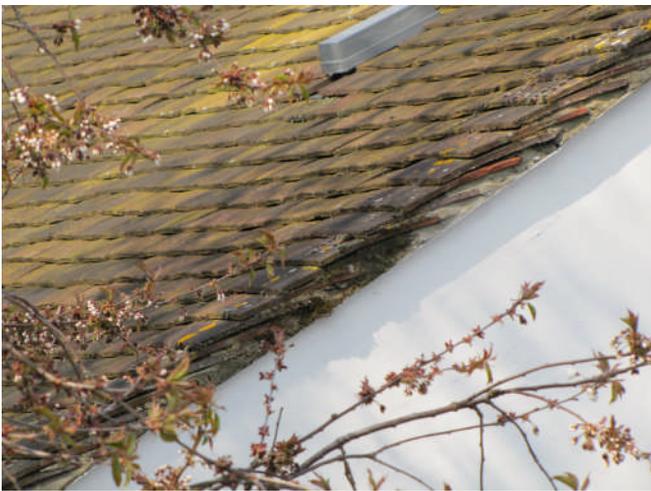
13. Verge pointing is becoming weathered in parts.

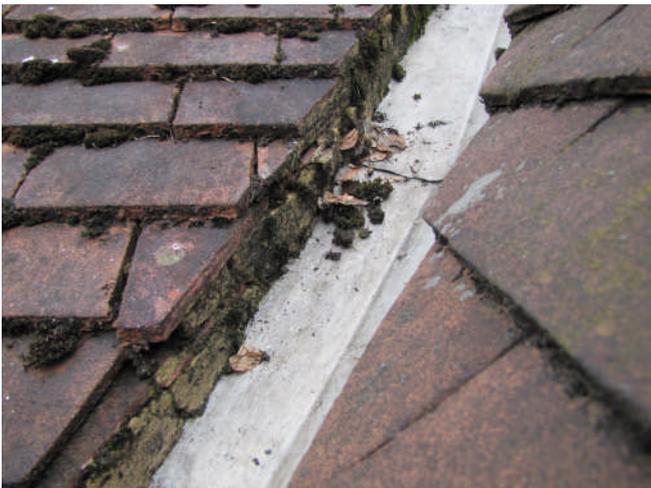
15. Mortar fillets adjacent to the valley linings are beginning to crumble.

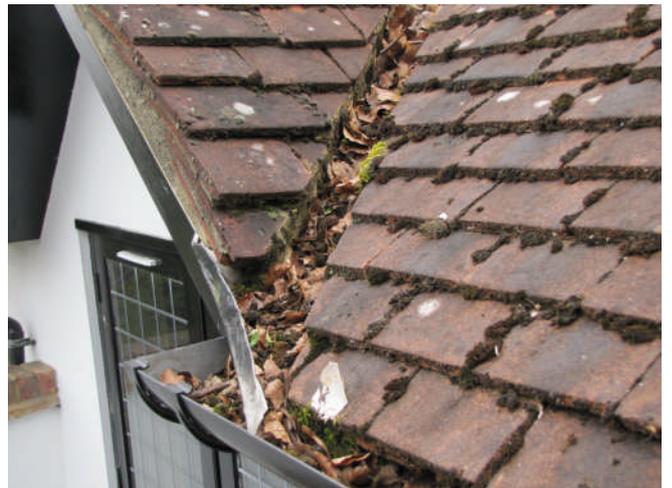
16. Leaves require clearing from valley gutters and rainwater fittings.

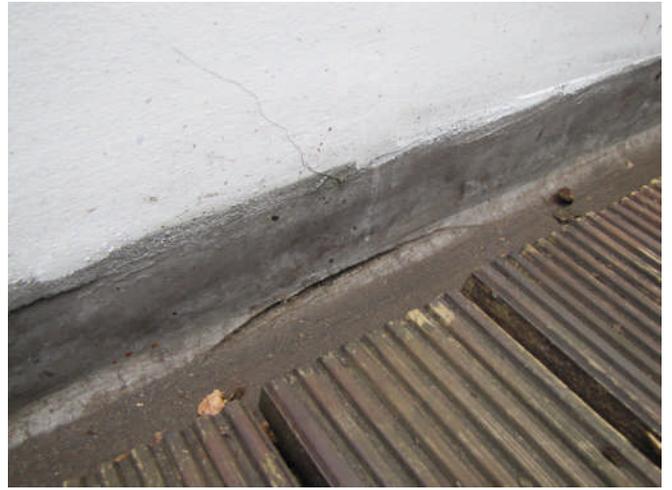
18. Split within the asphalt, at the rear edge of the roof terrace. NB also lead flashing absent.

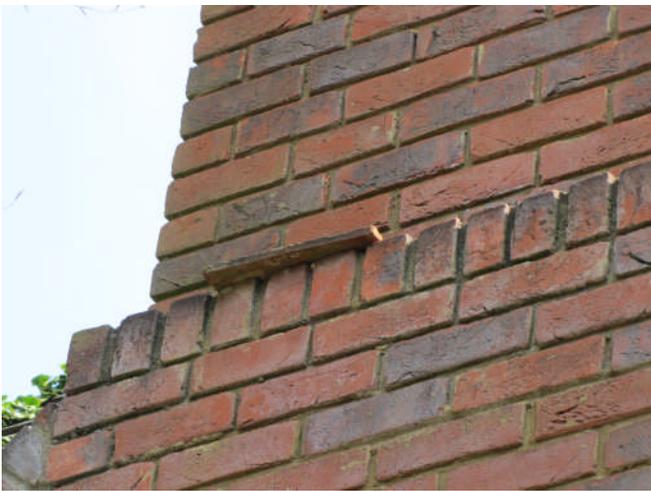
25. A loose tile on a high-level ledge is a potential hazard.

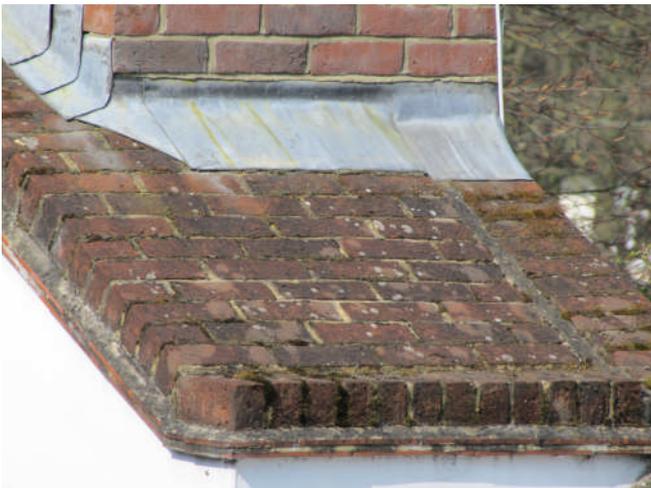
27. Sloping brick surface should be clad with lead sheet.

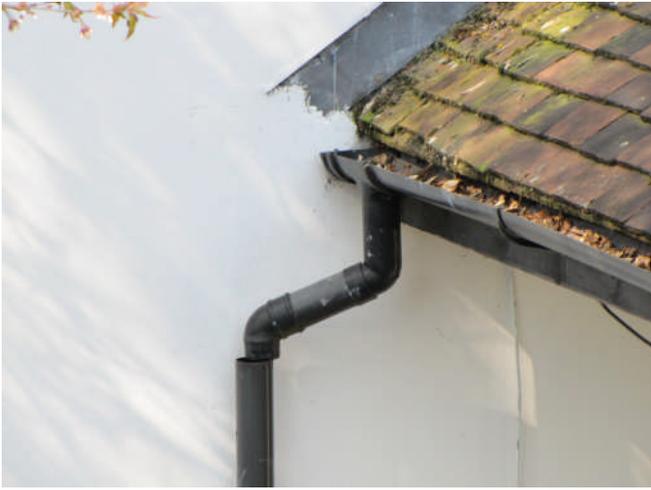
29. Leaves within the guttering and disconnected downpipe.

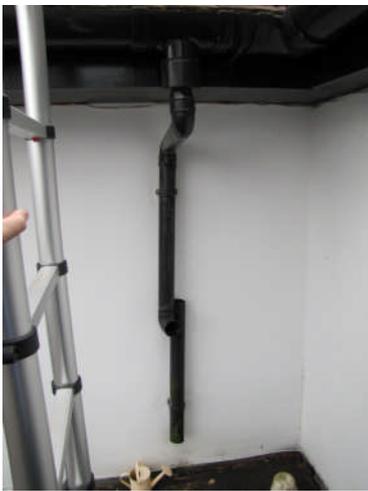
31. Broken downpipe, adjoining the roof terrace.

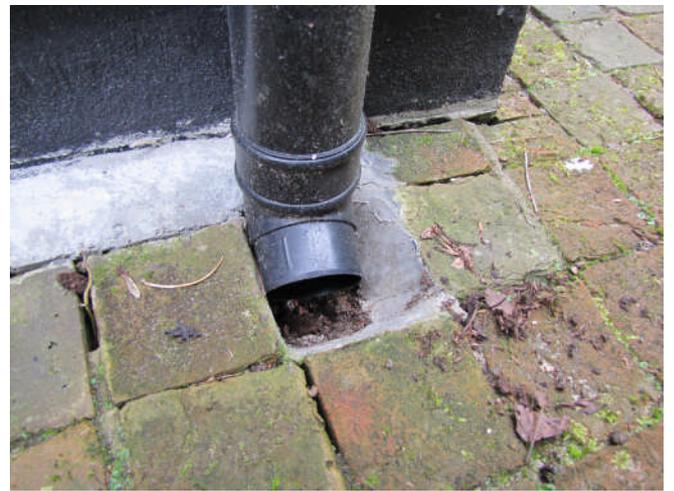
32. No proper gully is provided here.

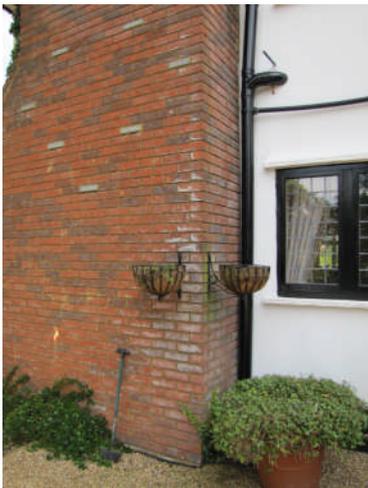
33. Water staining, where no rainwater fittings are provided

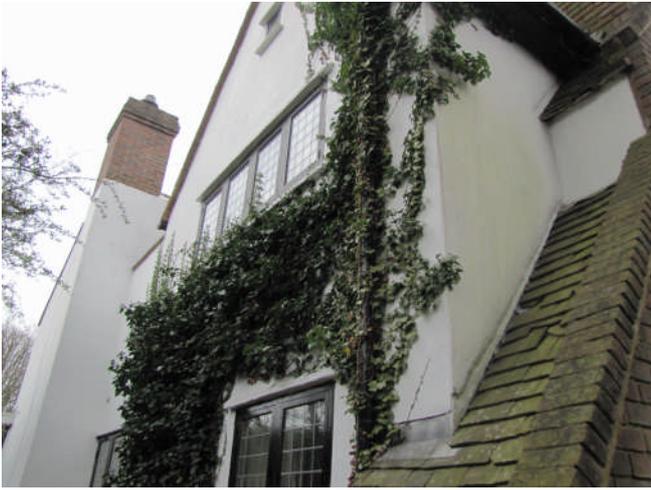
35. Ivy growth on the left hand flank wall.

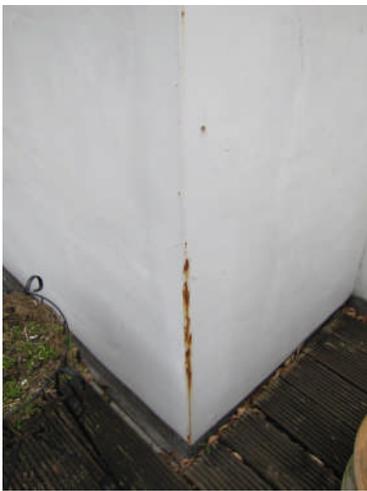
37. Rusting angle bead.

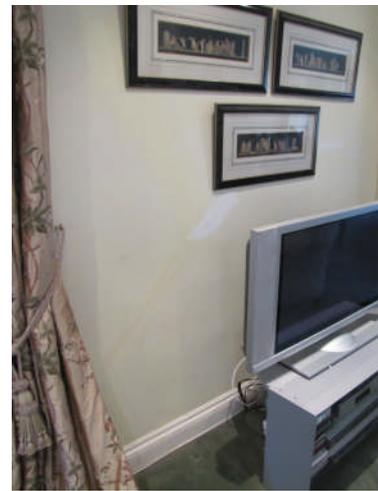
38. Internal cracking to the left hand flank wall in the main reception room.

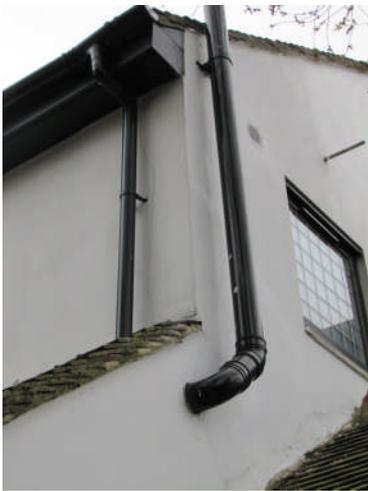
43. Minor external crack.

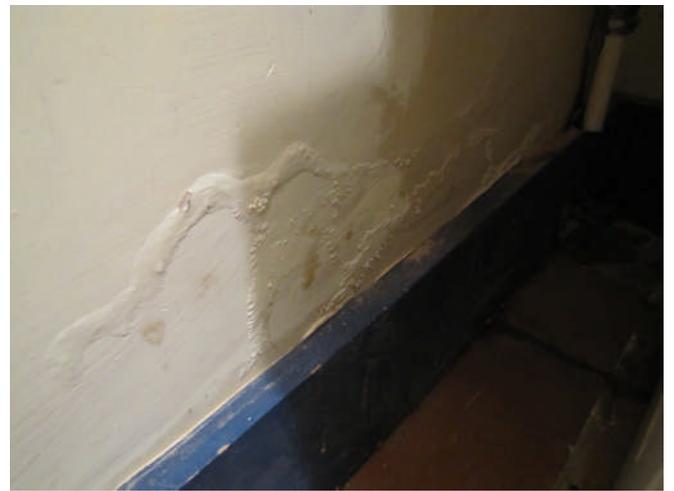
44. Water damage in the utility room.

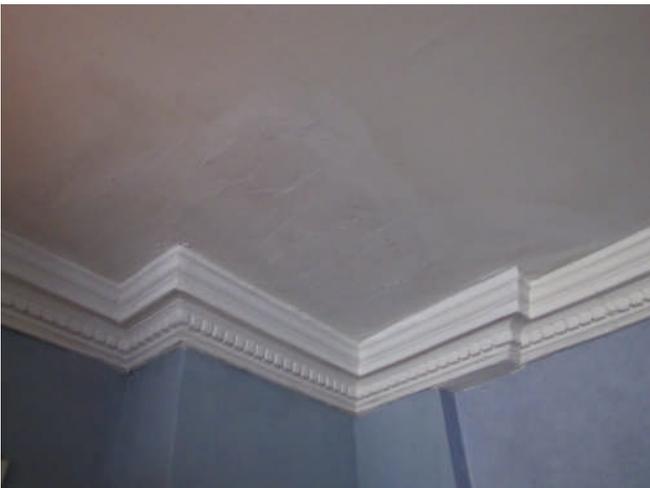
45. Water damage in the dining room.

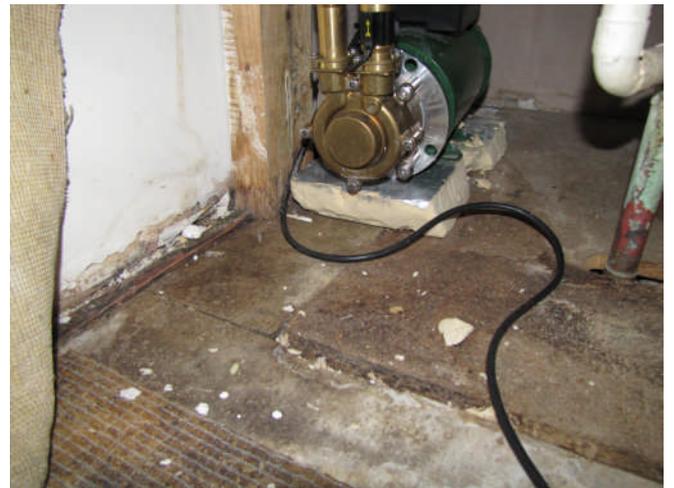
46. Pump has been leaking in the cylinder cupboard.

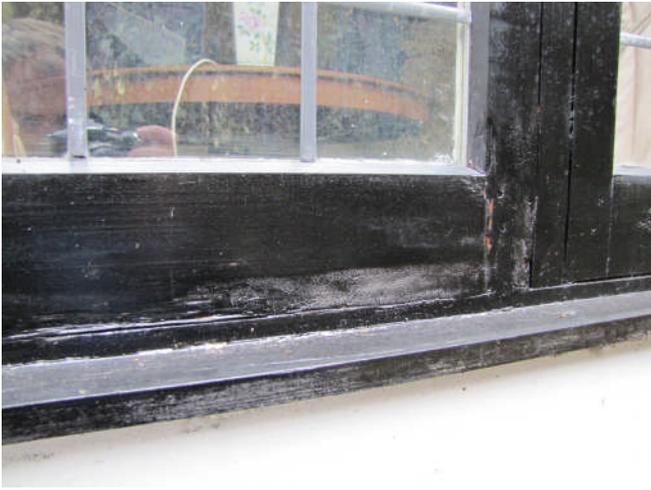
47. Rot within a window frame on the left side of the main reception room.

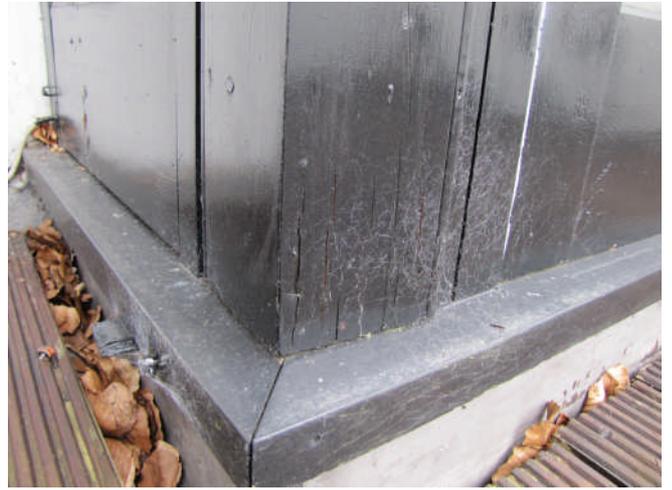
48. Rot within one of the posts forming the bedroom 2 bay frame.

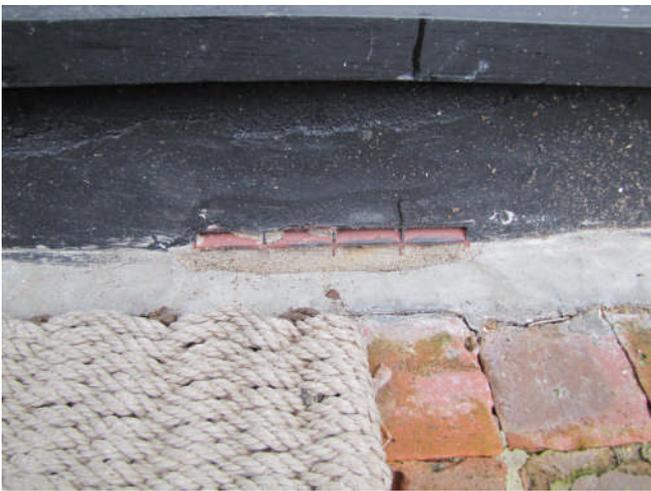
49. Obstructed airbrick at the rear of the reception room.

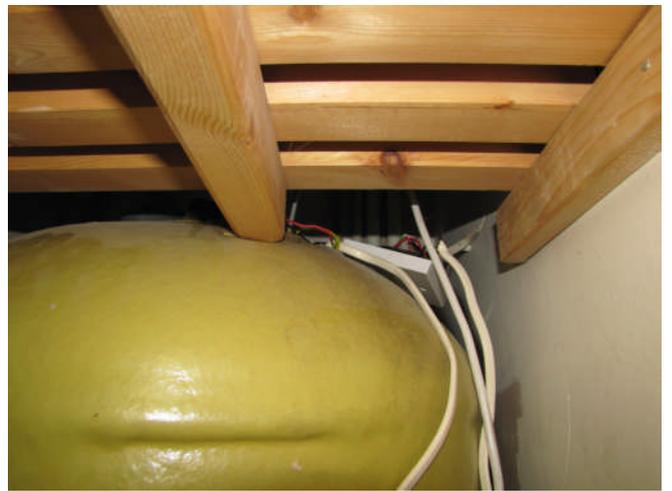
50. Electrical hazard in the cylinder cupboard.

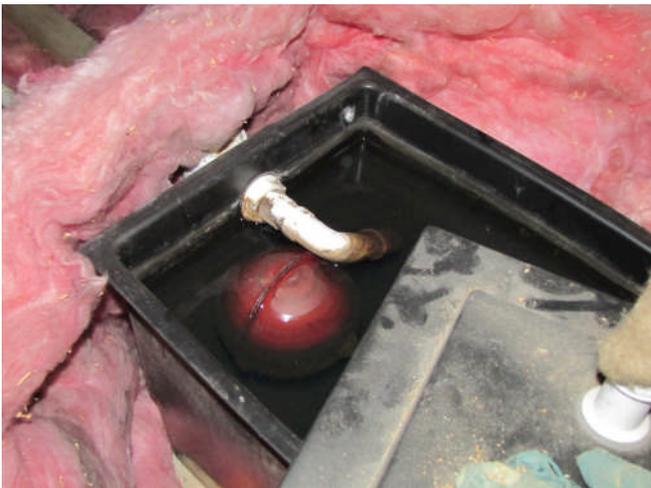
51. Sunken ball valve in the feed and expansion tank.

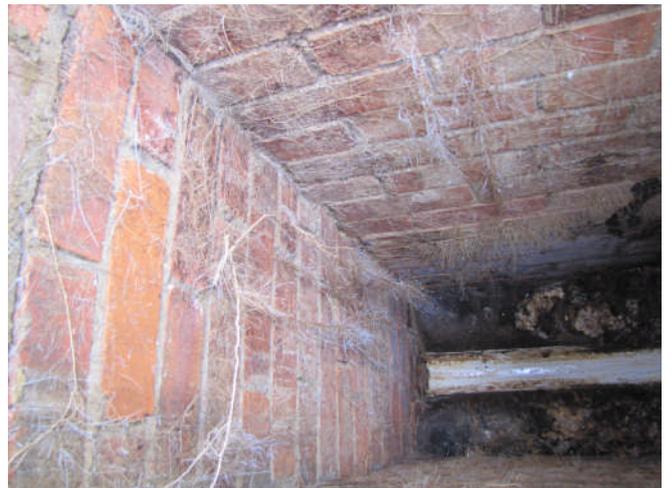
52. Root penetration into the drainage system.

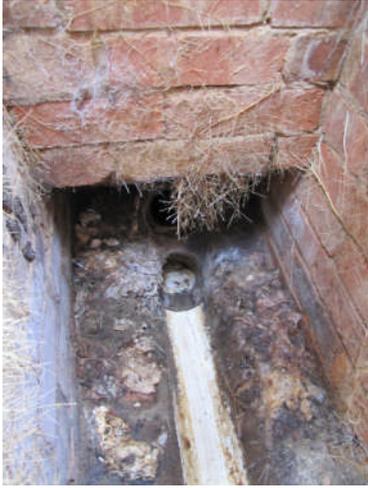
53. Roots within the interceptor chamber. NB also missing rodding eye stopper & rat droppings.

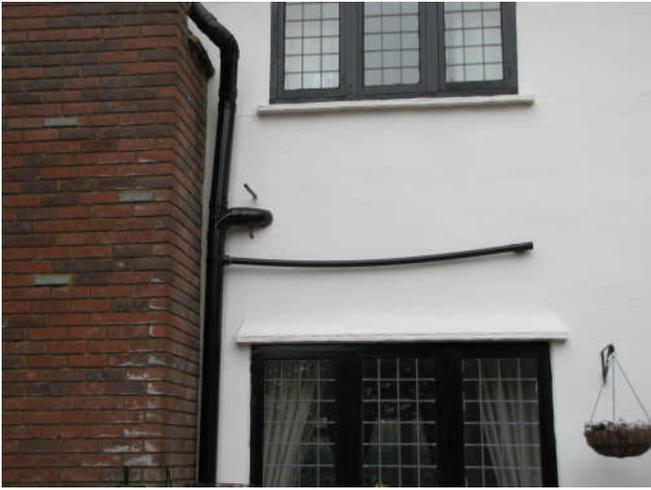
59. Sagged waste pipe connection to the 'soil and vent' pipe at the front.

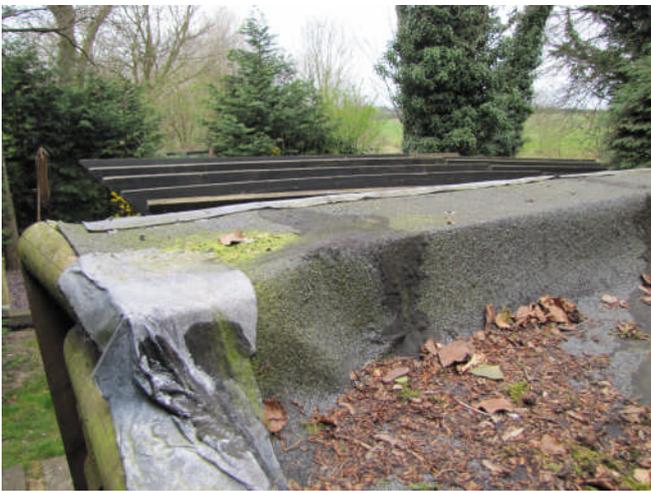
61. Felt covered roof and poor detailing.

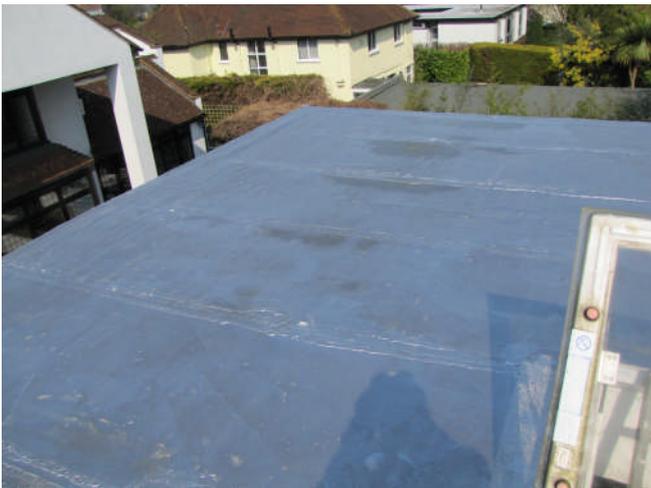
63. Buckled flat roof surface, on the annex.

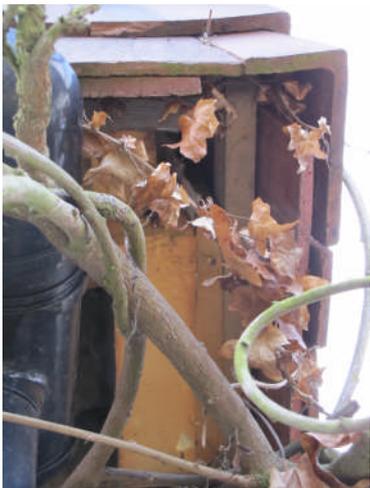
69. Missing soffit board at the front/left corner.

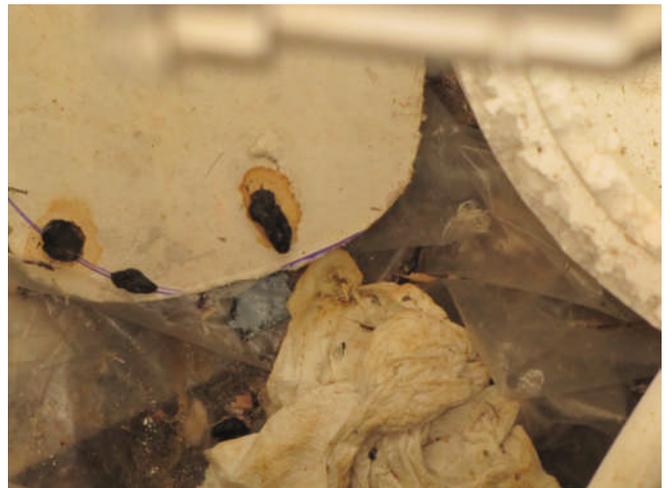
70. Droppings within the mansard void suggest possible squirrel infestation.

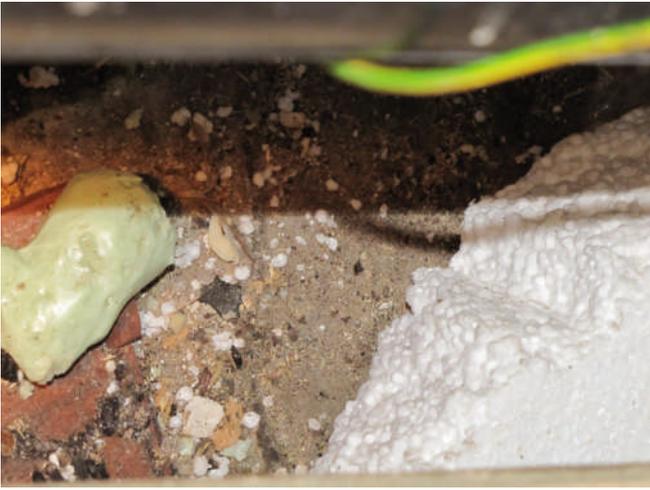
71. Signs of knawing.

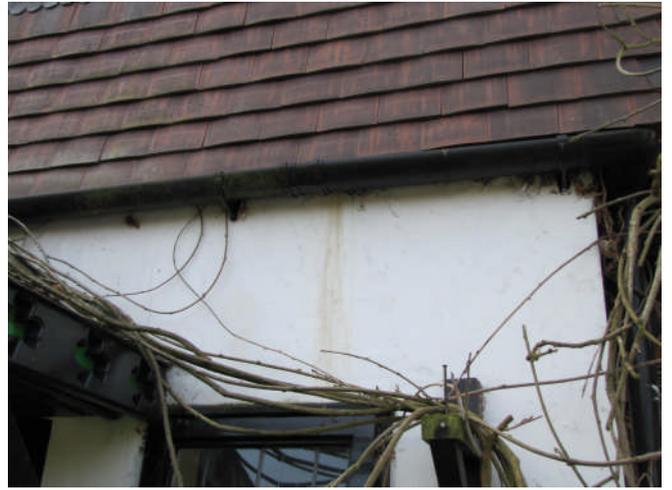
72. Signs of gutter leakage.

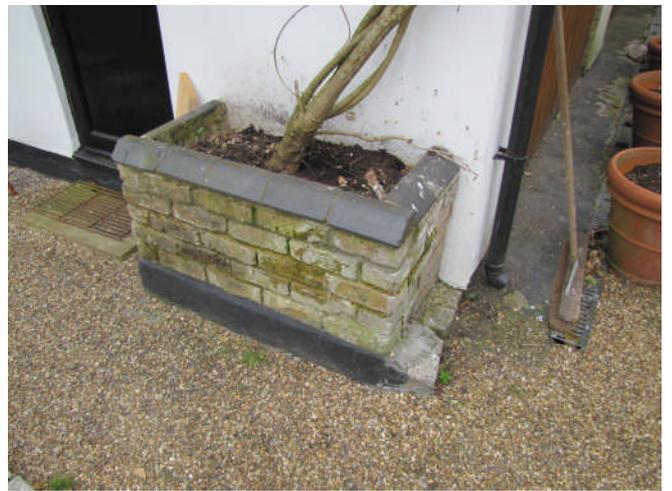
74. Planter 'bridges' the dpc.

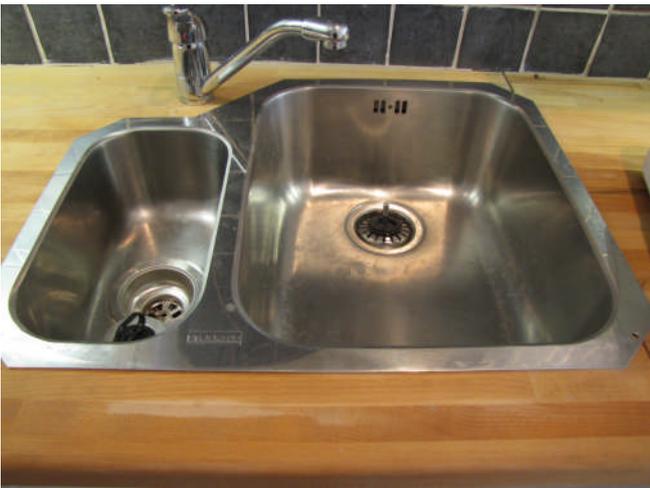
75. Sink top installation has not been completed correctly.

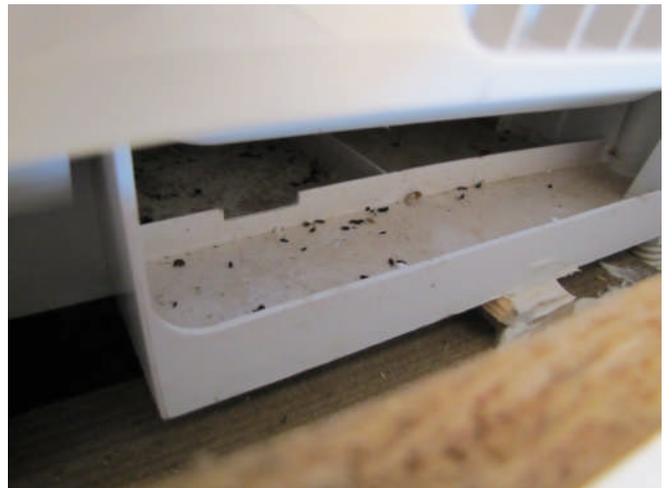
76. Mouse droppings underneath the freezer.

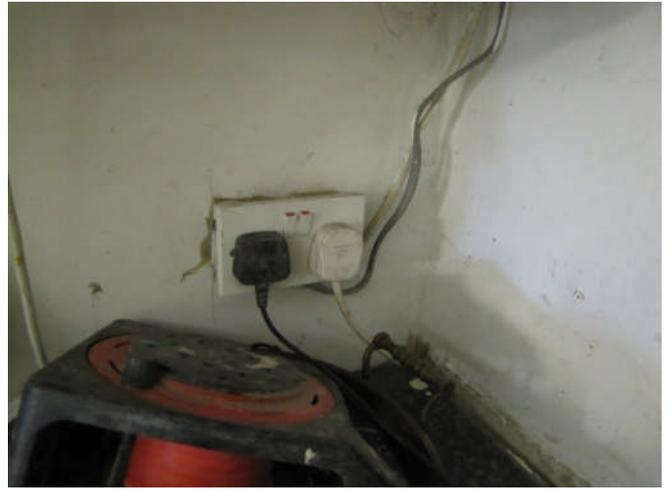
78. Loose supply cables to 13 amp sockets in the garage.

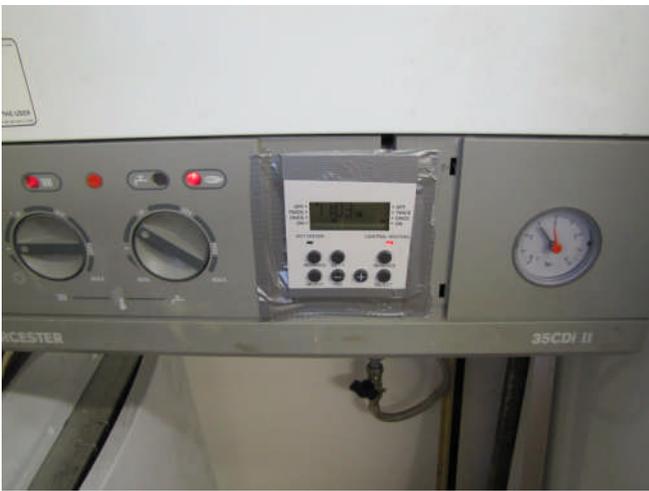
79. Clock is retained by tape.

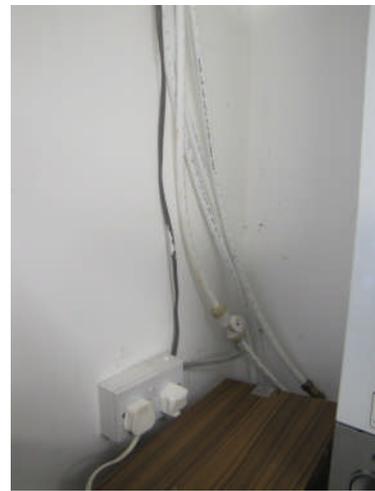
80. Loose central heating pipework (and electrical cables).

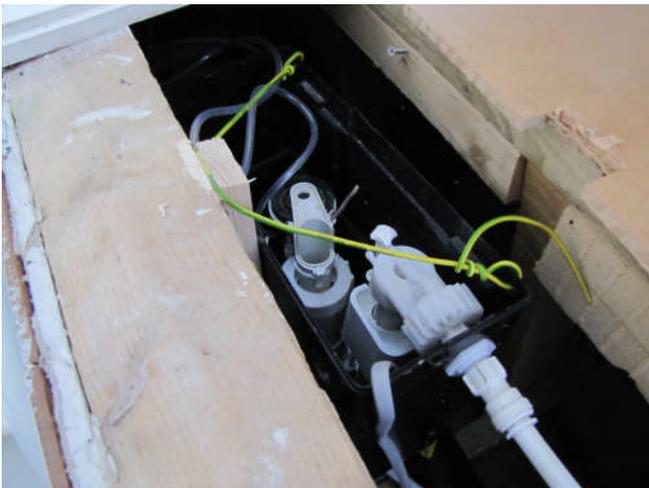
81. Poor quality WC installation.

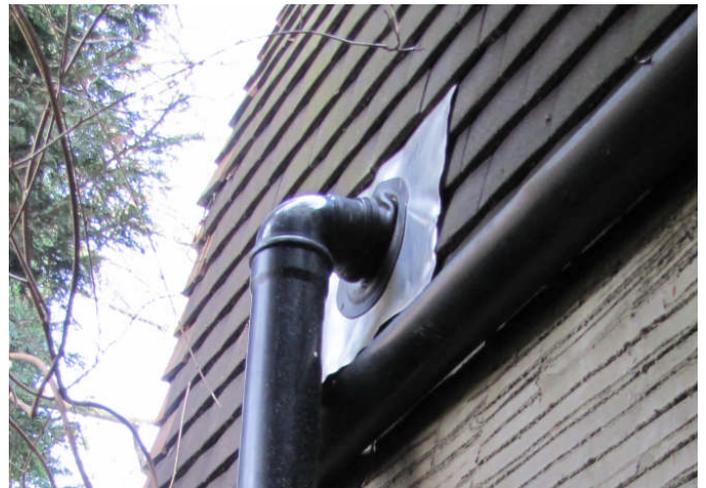
82. Aluminium/rubber gasket should be fitted behind the tiling.
