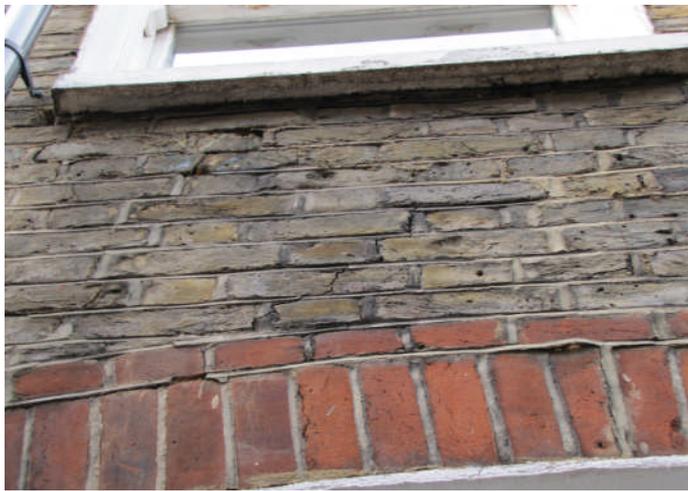
3. Cracking between the ground and first floor window openings, on the right flank elevation.

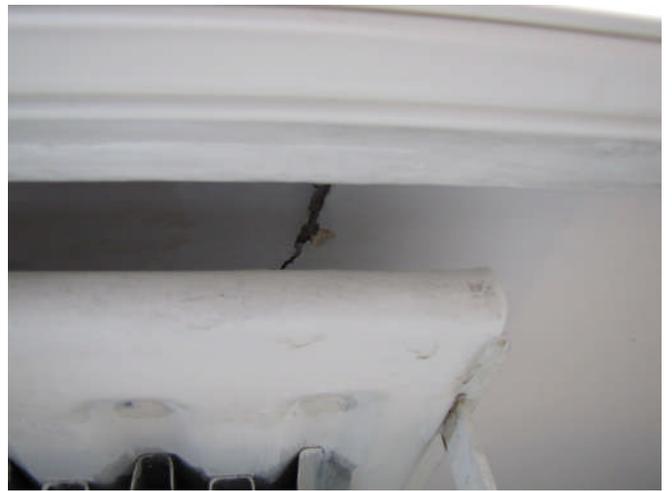
4. Minor, corresponding crack behind the radiator in bedroom 2.

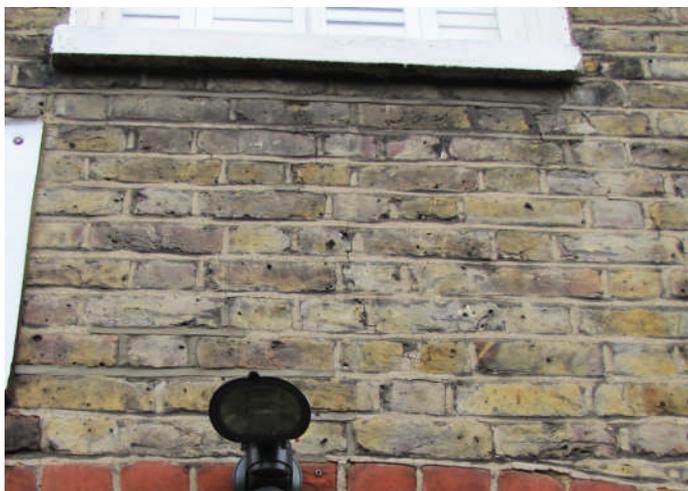
5. Minor cracking above the kitchen French doors, within the rear elevation.

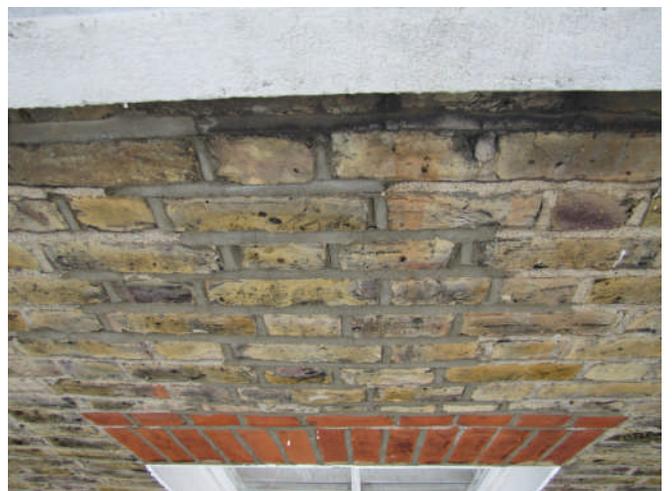
6. Area of repointing and suspected crack repairs between the first and second floor window openings, at the rear.

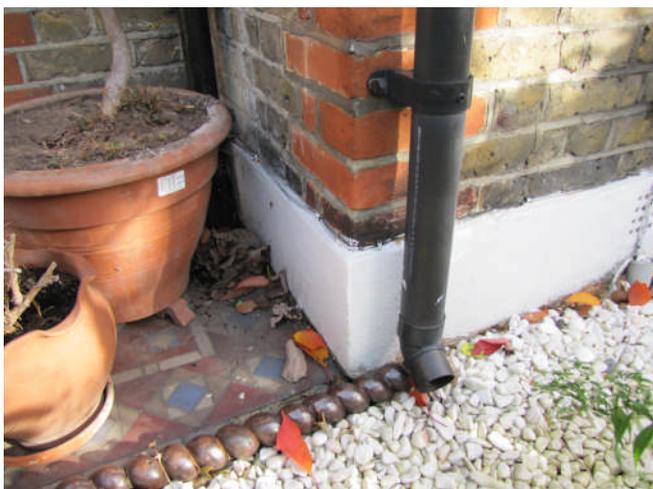
7. The render plinth is likely to 'bridge' the dpc. The rainwater pipe should be extended round to the nearby gully.

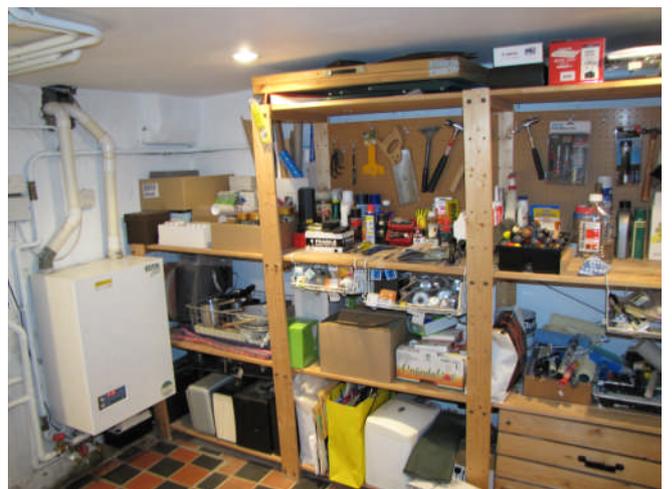
8. Limited inspection in the cellar.

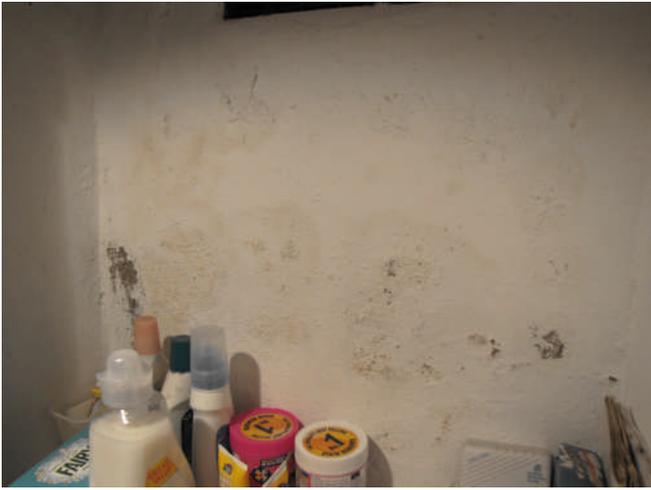
9. Perished render-tanking in the cellar, to the right hand flank.

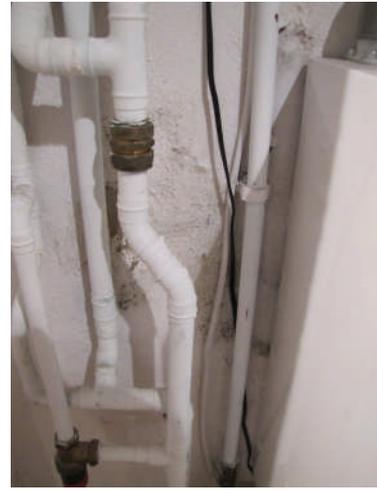
10. Perished tanking.

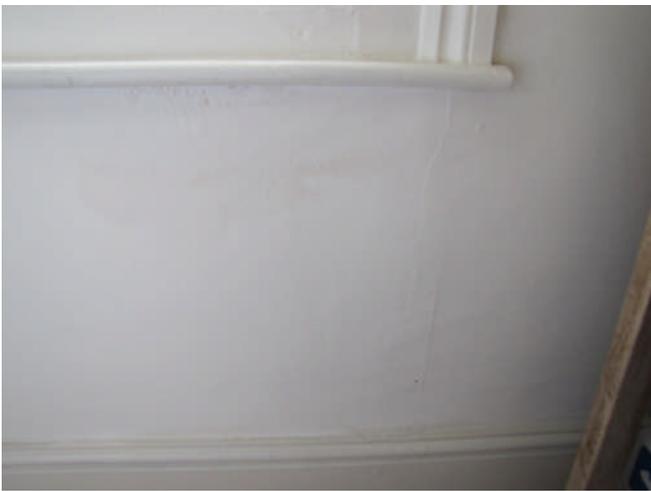
11. Damp stain beneath the window in bedroom 5.

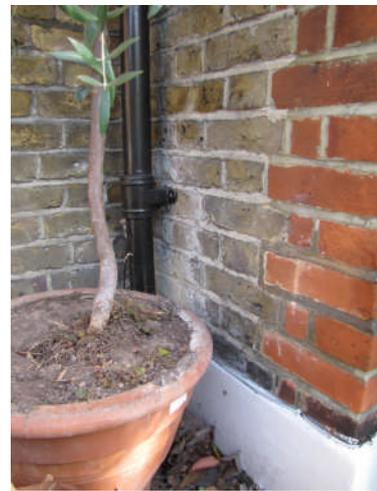
12. Stained brickwork behind the rainwater pipe within the porch.

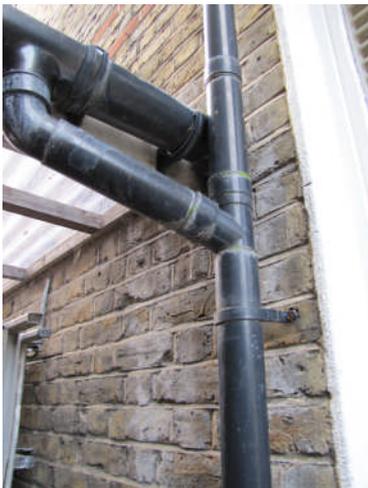
13. Stained brickwork behind the rainwater pipe on the flank wall, adjoining the lean-to.

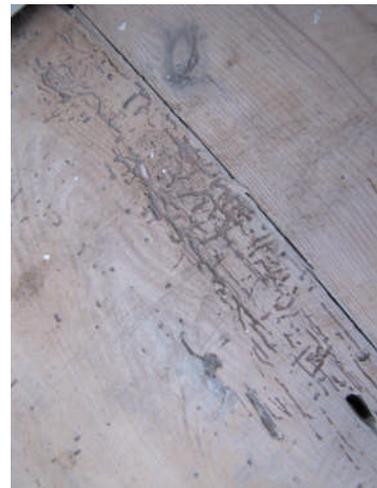
14. Woodworm damage to exposed floor timbers.

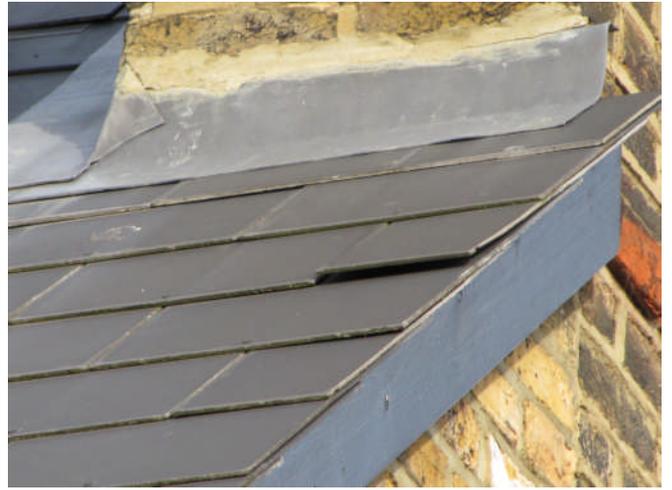
16. Cut (half) slate is lifting slightly, at the verge.

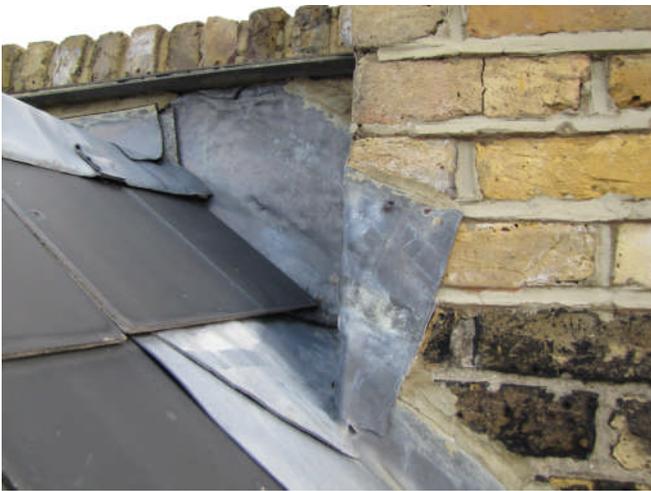
17. Nailed flashing behind the chimney stack.

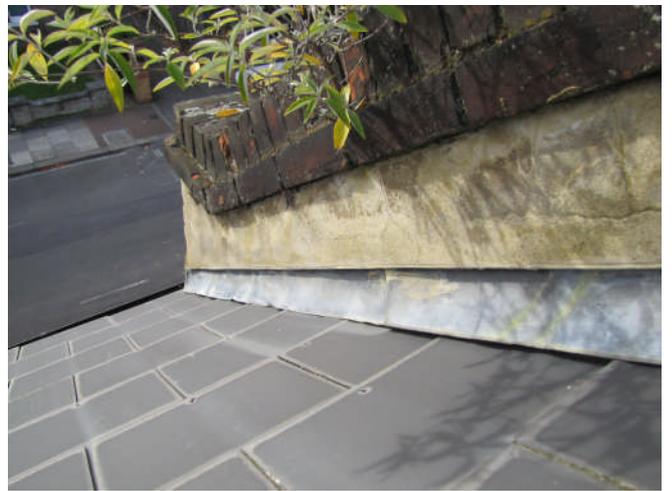
18. Party parapet wall, with vegetation growing from the weathered brick on edge coping.

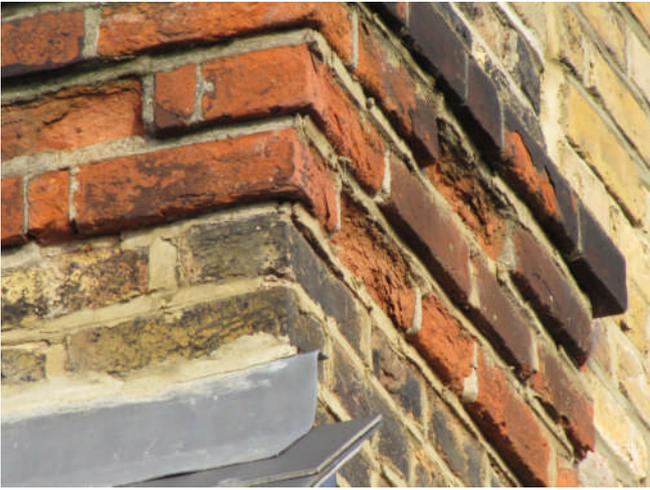
21. Spalling red brickwork on the front stack.

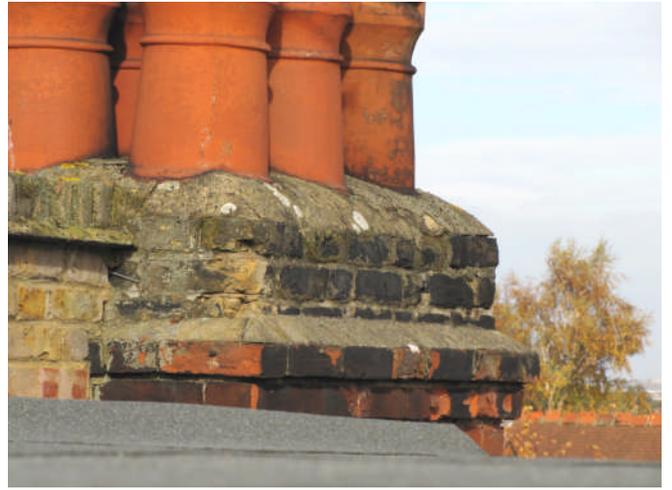
22. Red brickwork is also weathered/decayed on the rear stack.

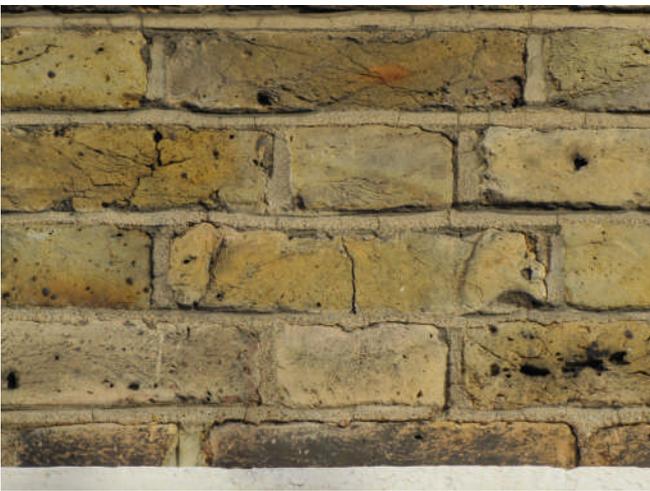
23. Weathered pointing.

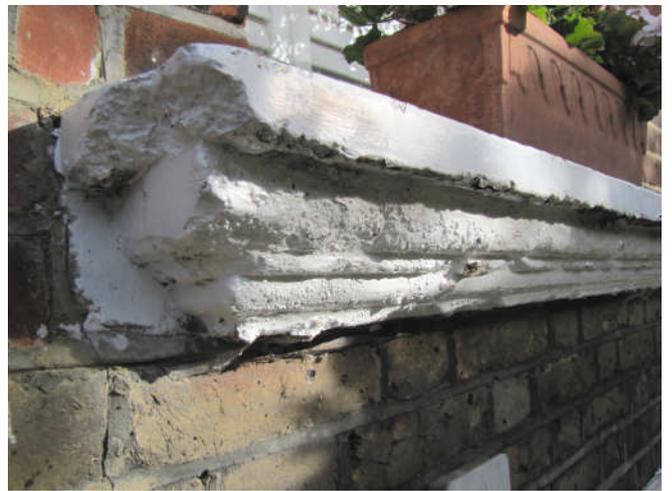
24. Perished stone subsill to the front bay.

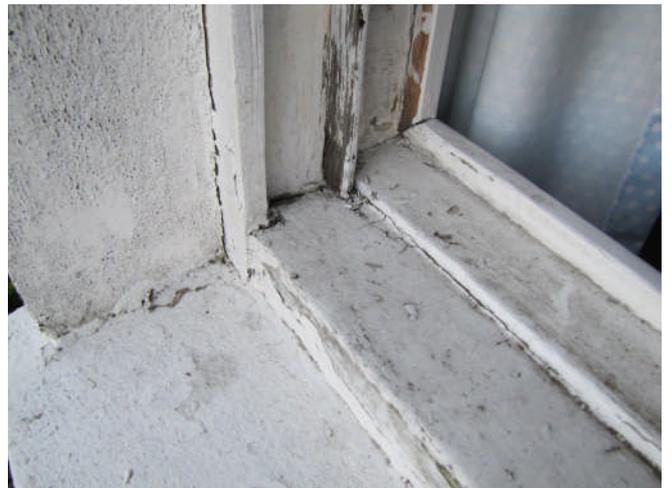
26. Weathered sash window (bedroom 5).

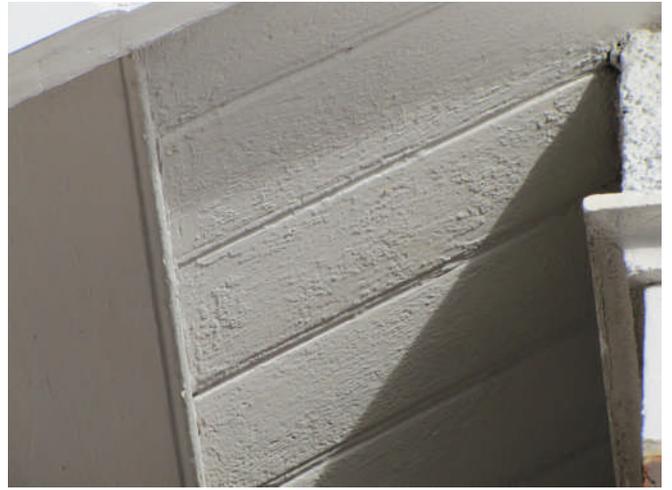
28. Poorly prepared woodwork at high level to the soffit boarding, at the front.

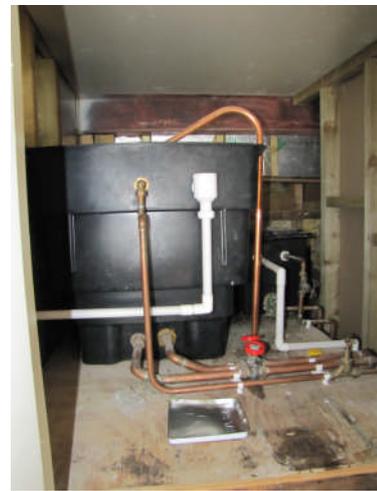
30. Cold water tank (requires a lid).

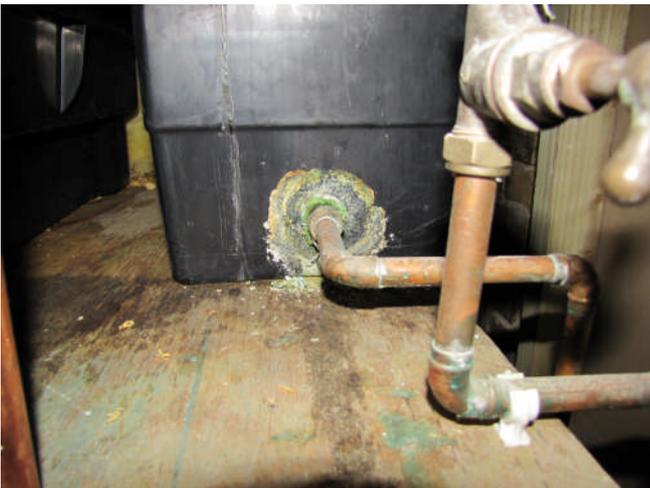
31. Leak from the feed and expansion tank.

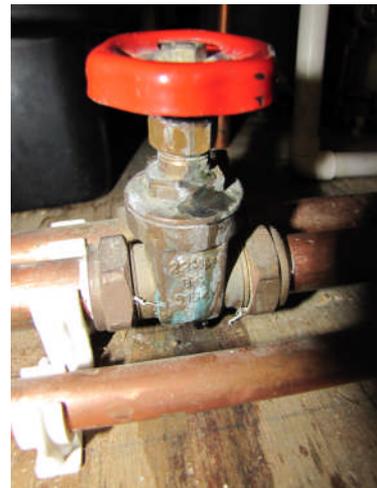
32. Leaking gate valve on a 'down' service.

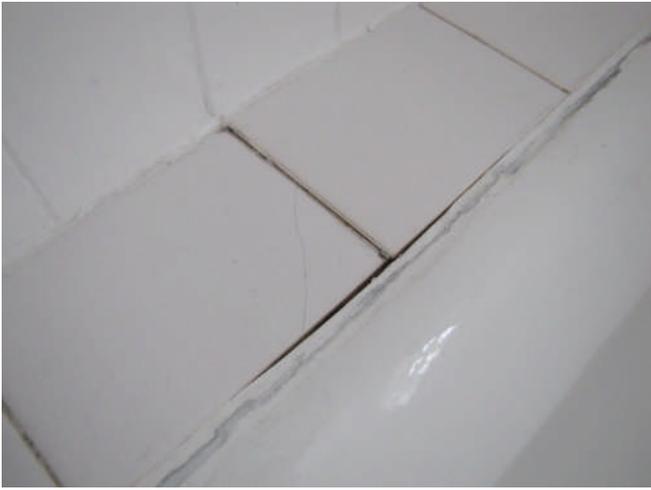
33. Split mastic, adjacent to the bath.

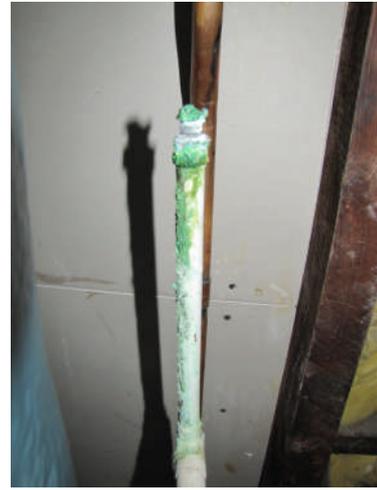
34. Limescale on the vent, adjacent to the hot water cylinder.

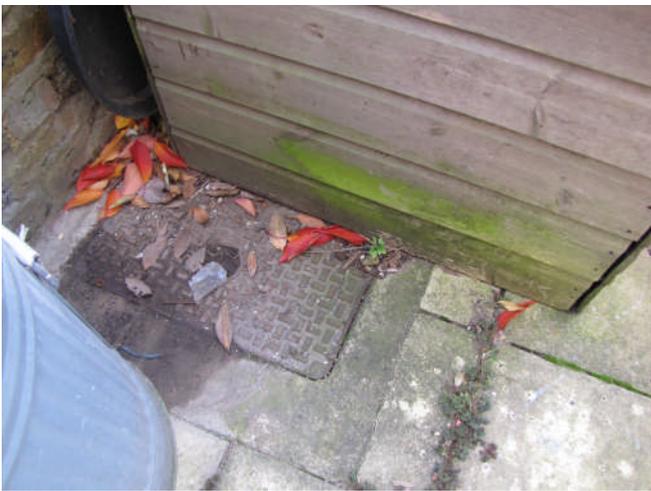
35. Inaccessible manhole at the front of the site.

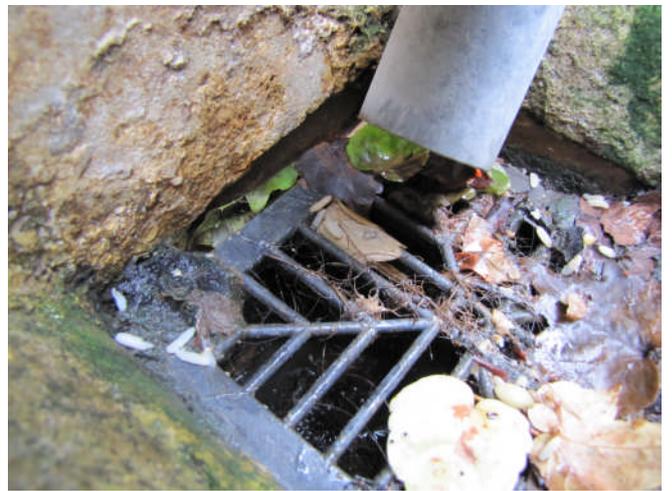
36. Any gapping around the gully will allow leakage into the soil.

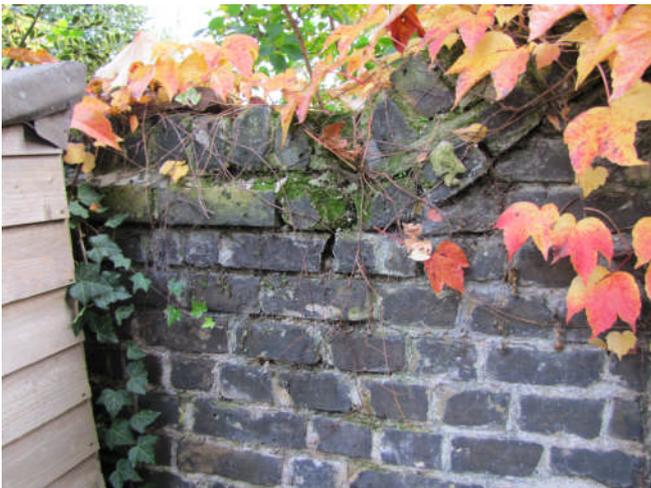
37. Weathered brickwork to the right hand boundary wall.
