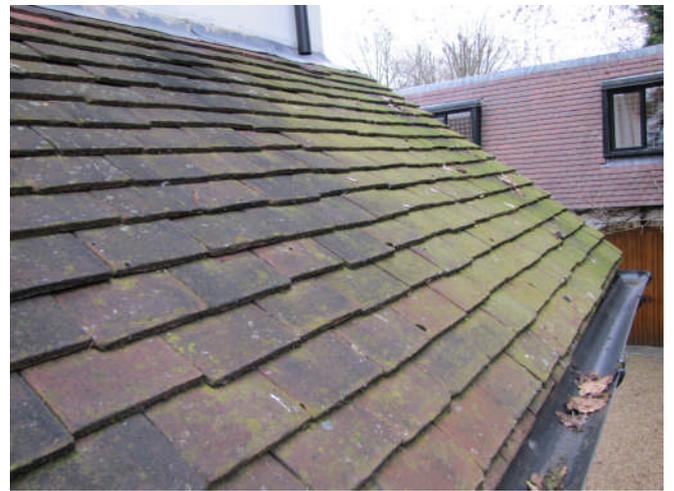
8. Tiles on the roof of the single storey side extension.

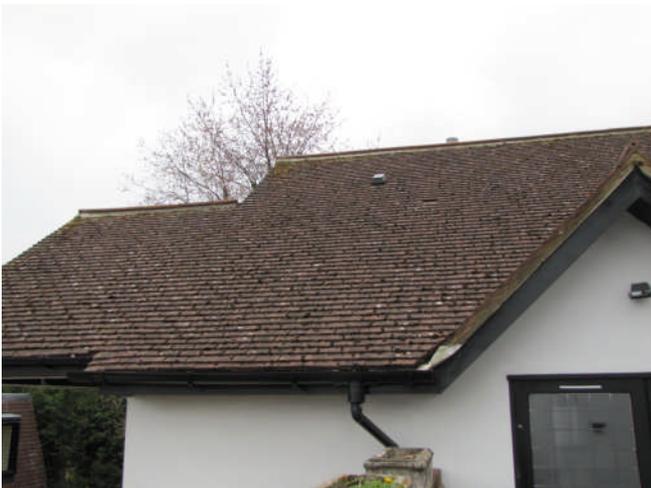
9. Concrete tiles on the roof of the two storey extension (left side).

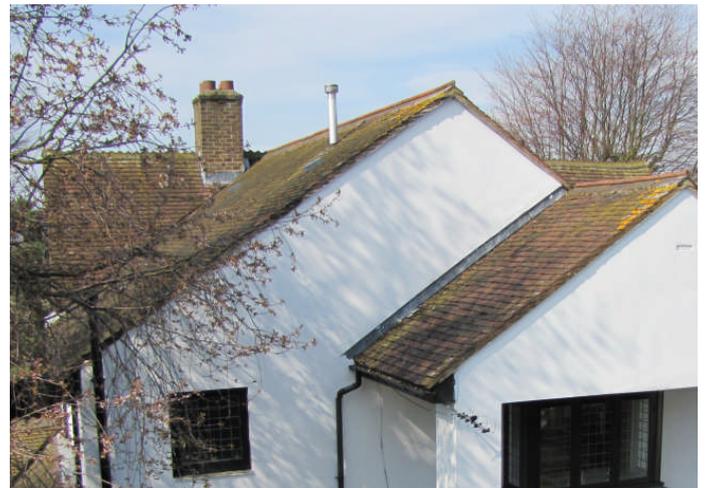
10. Limited view of the right hand side.

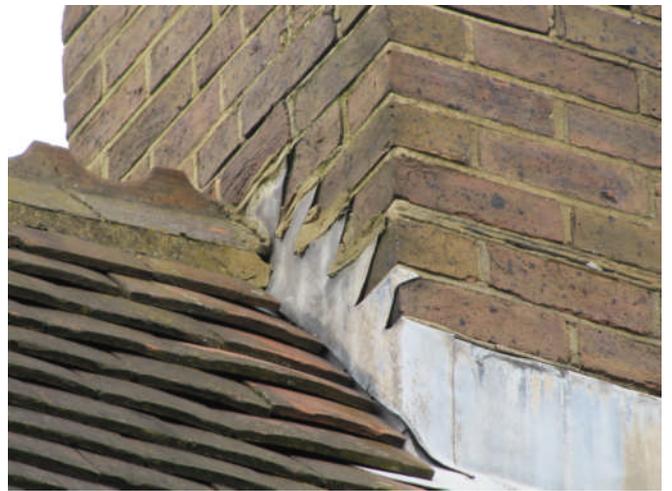
14. Lead flashing.

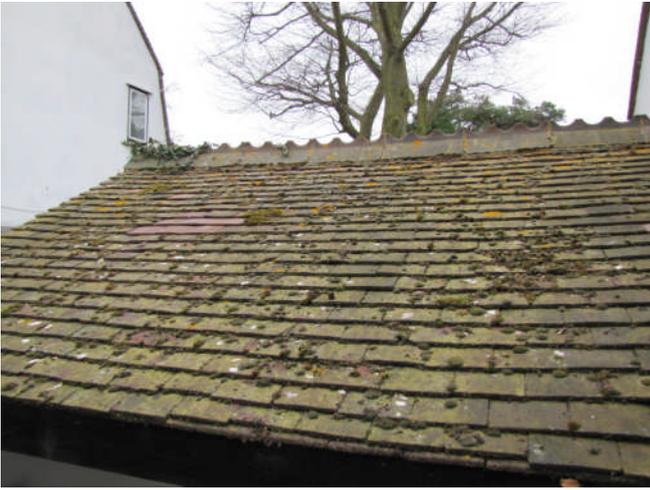
17. Old, reclaimed tile covering on the roof of the drive-through.

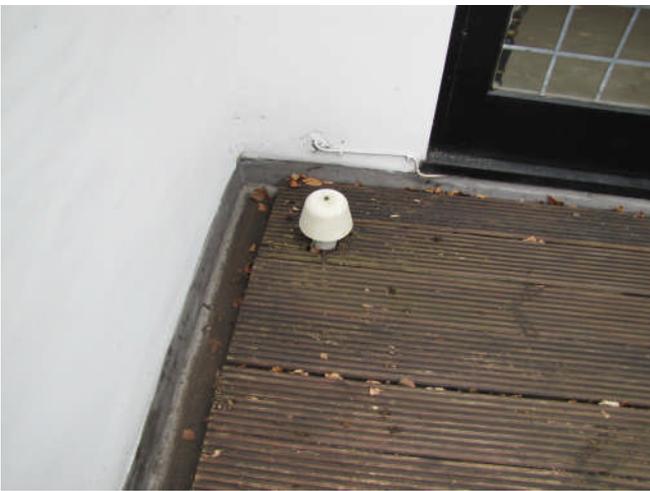
19. Ventilators are provided in the four corners.

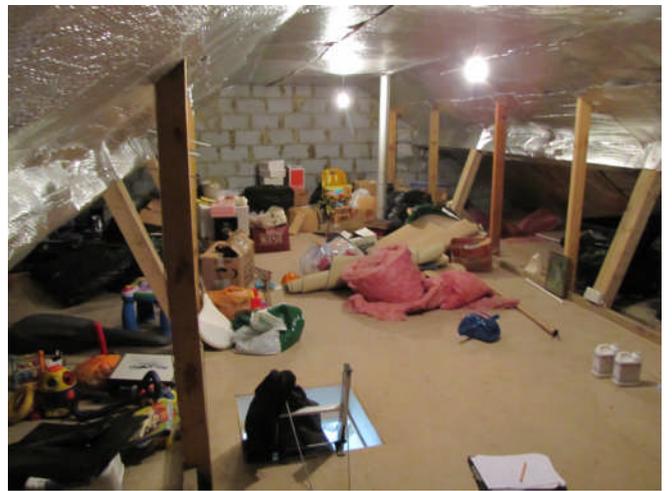
20. Roof space (extended section).

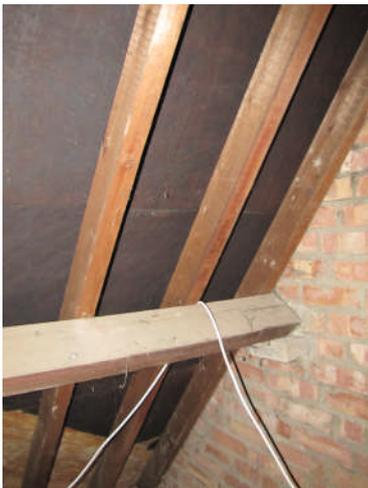
21. Roof frame within the original section of the roof space, with bituminous paper sarking.

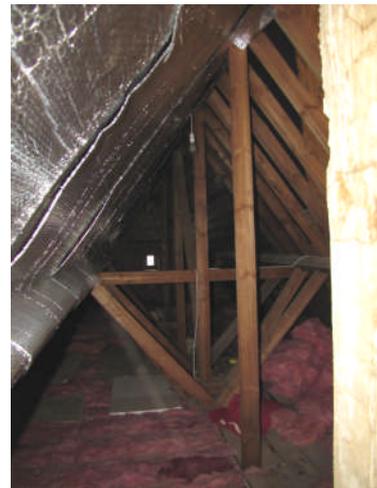
22. Original roof framing.

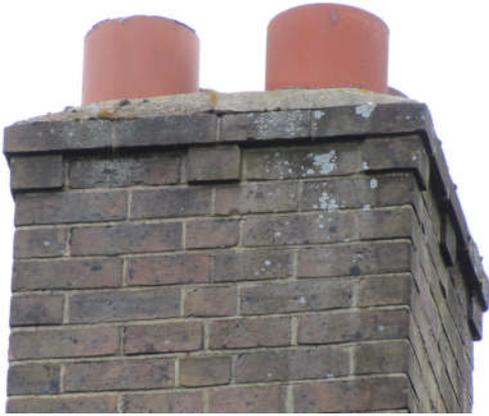
23. The original chimney stack.

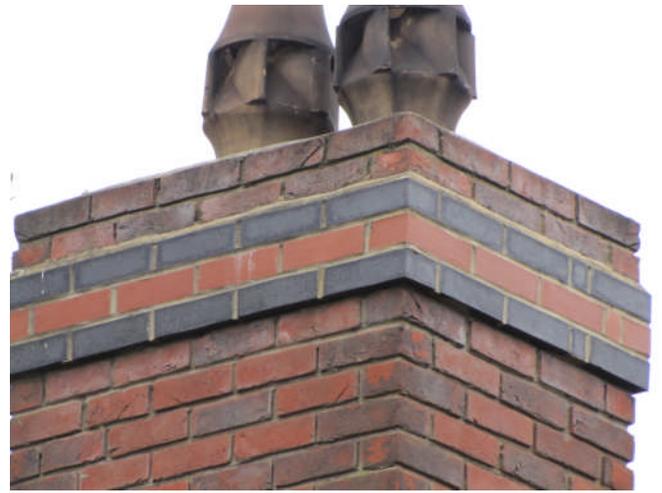
24. 'Inglenook' chimney.

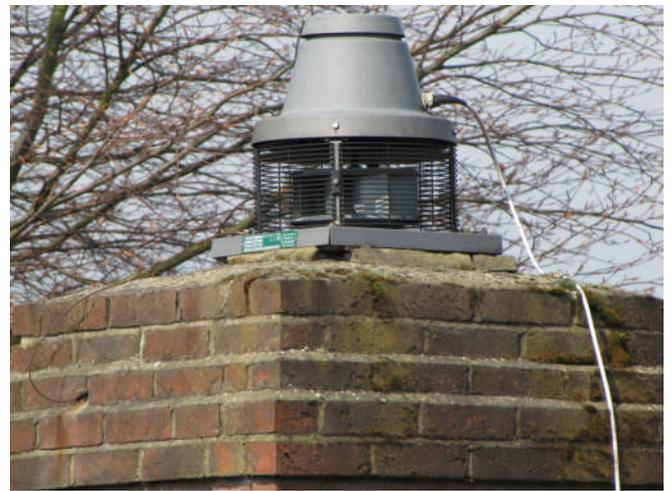
26. Flue fan on the rear/left chimney stack.

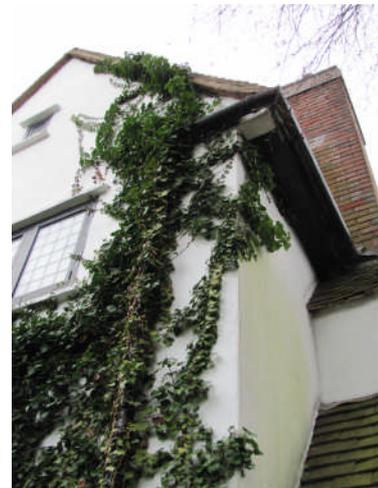
28. Ivy on the left hand flank wall; wrapped around the rainwater pipe and reached gutter level.

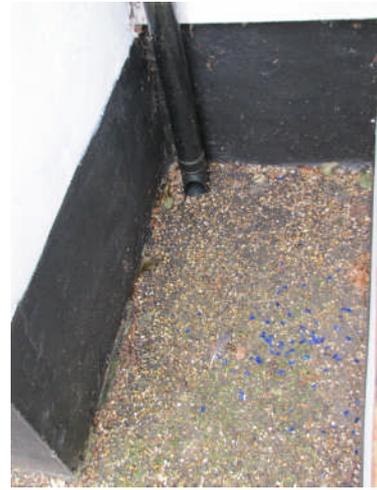
30. No rainwater gully is provided.

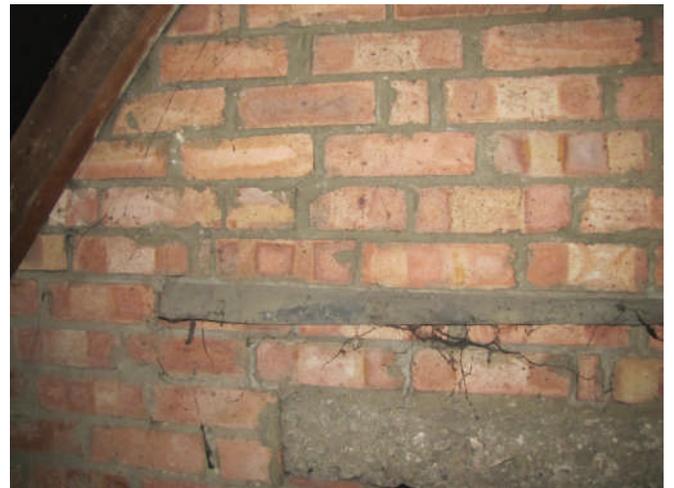
34. Inner leaf of the cavity wall, with lead cavity tray; seen from the roof space.

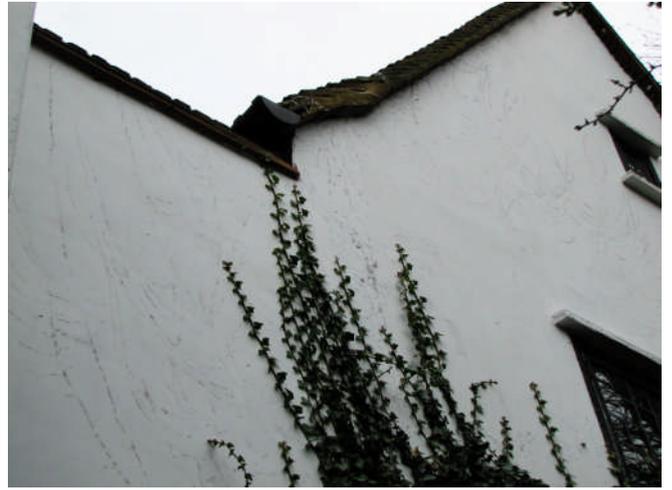
36. Marking on the wall surface.

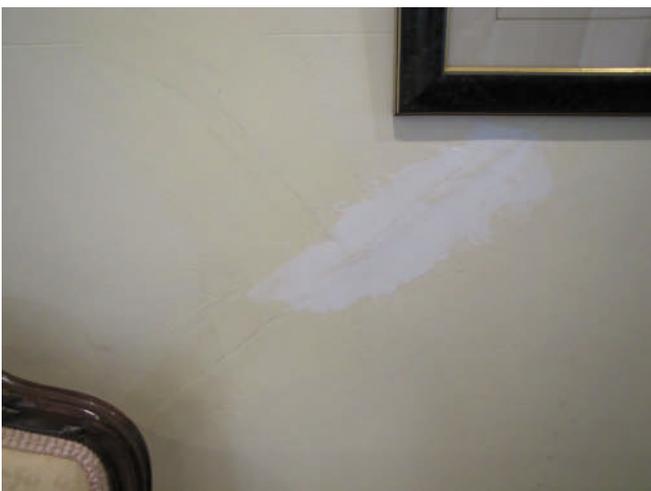
39. Filler repair; part painted.

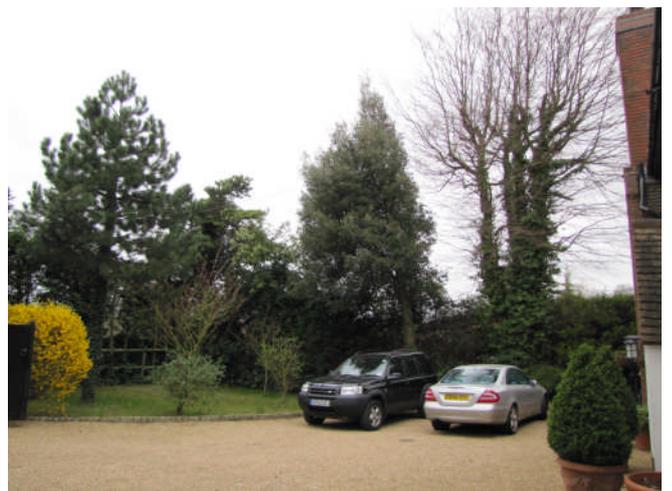
40. Trees on the left hand side of the front garden.

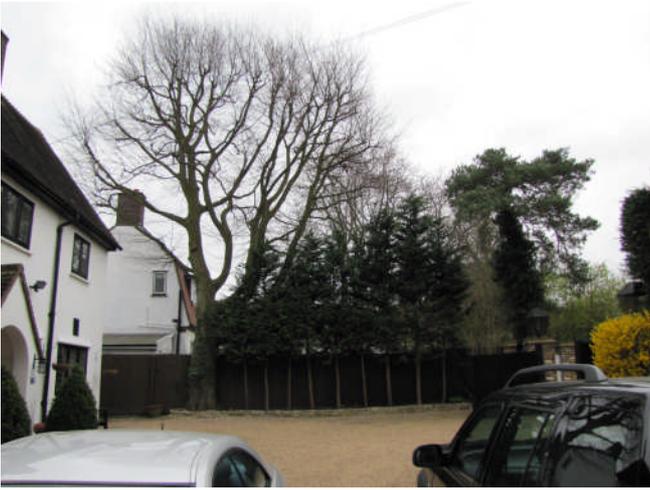
41. Tree on the right hand side - possibly a beech.

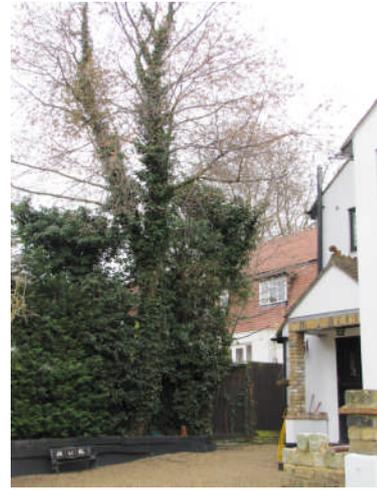
42. Leaning tree adjoining the right hand boundary (possibly a silver birch).

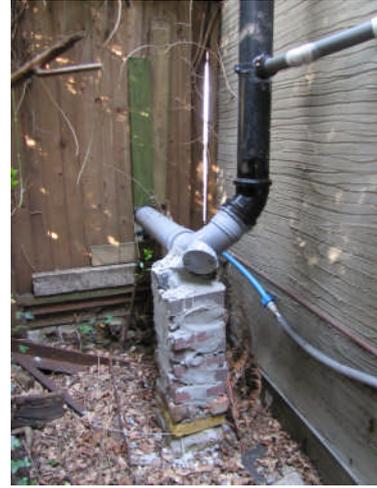
54. Drainage connection from the annex. NB also incoming water supply pipe.

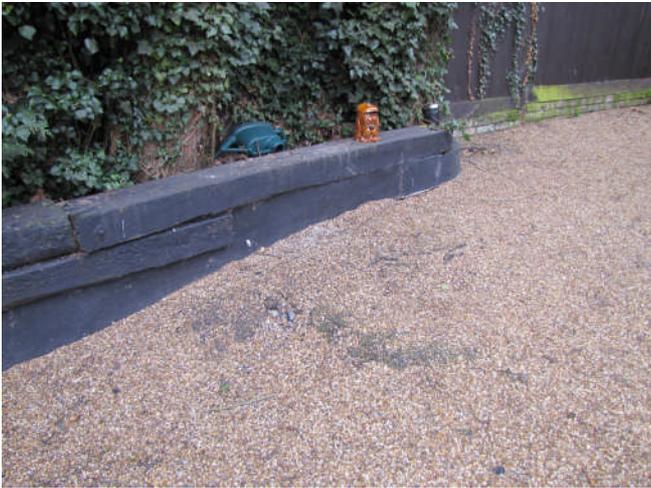
55. Planter, alongside the right hand boundary.

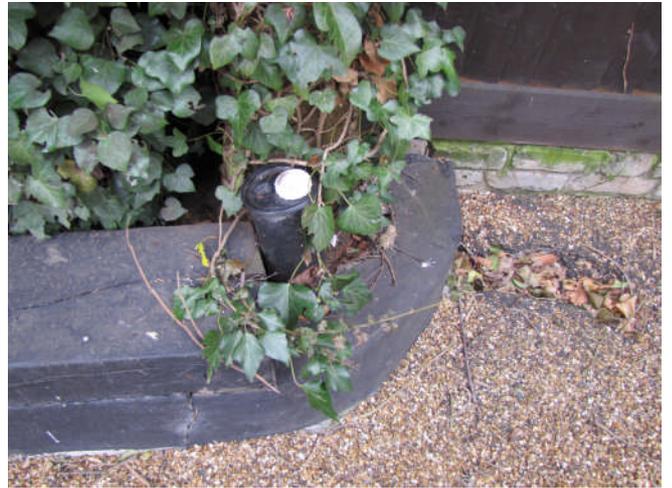
56. Rodding access.

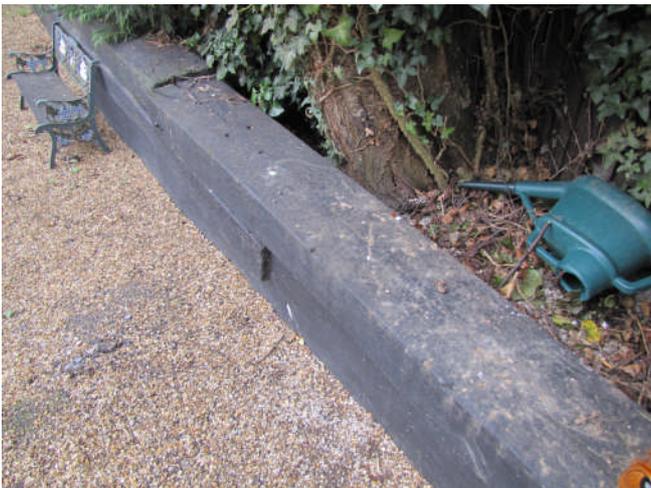
57. Sleepers forming the planter; on top of a brick or block wall.

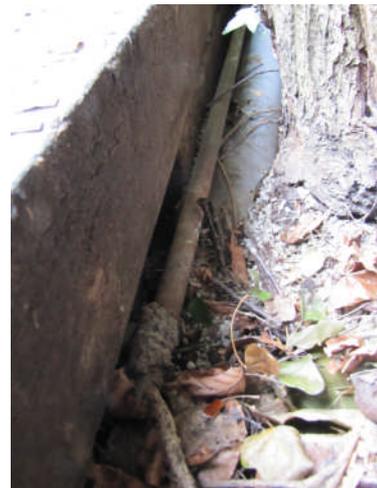
58. Gas pipe drainage pipes are squeezed between the immovable section of the planter wall and the tree.

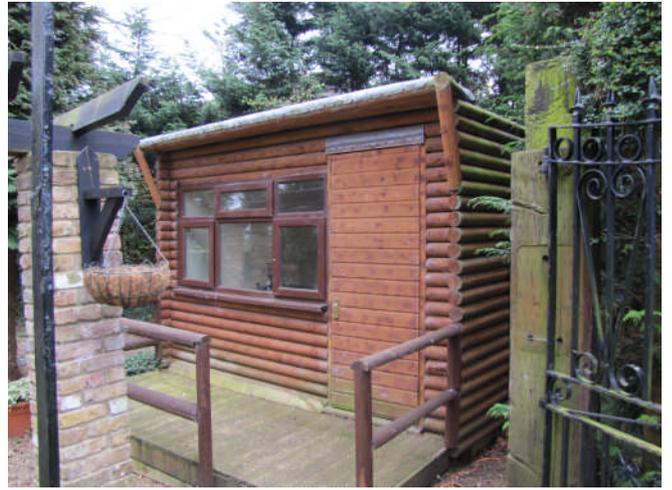
60. Log cabin.

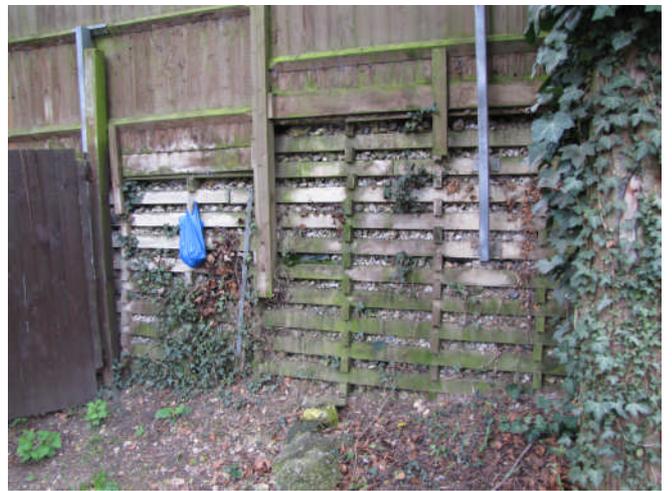
62 Retaining structure to the right hand boundary.

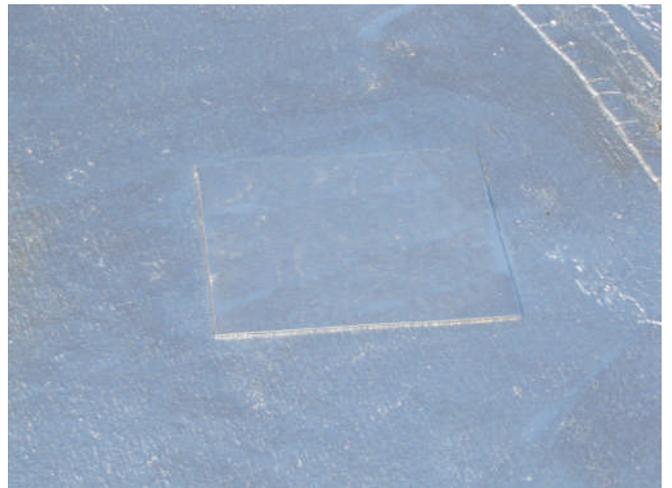
64. Patched felt.

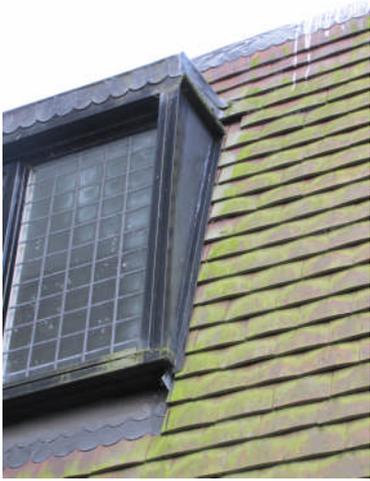
65. Dormer projection, with concealed 'soakers' at the abutment with the tiling.

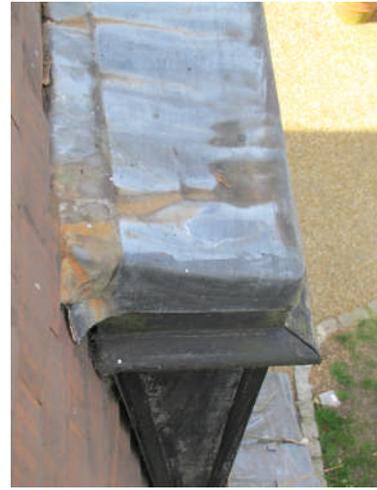
66. Lead covering on the dormer flat roofs - not installed to the highest standard.

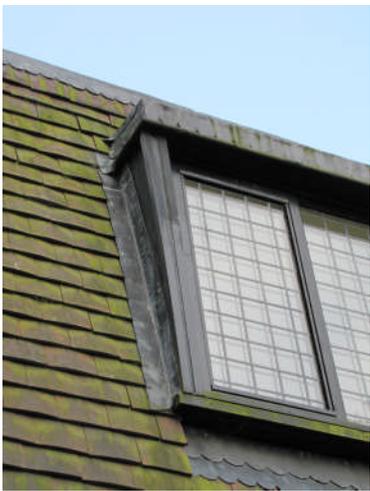
67. Lead flashings on one particular dormer.

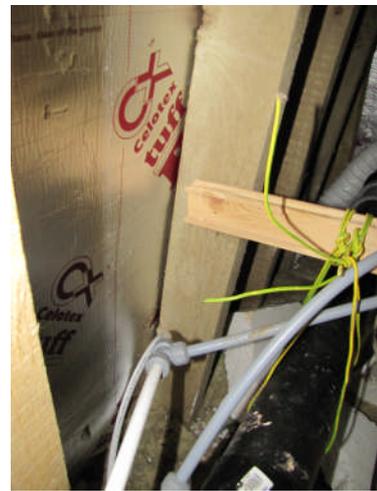
68. Timber framing and insulation forming the mansard are partially visible from the bathroom.

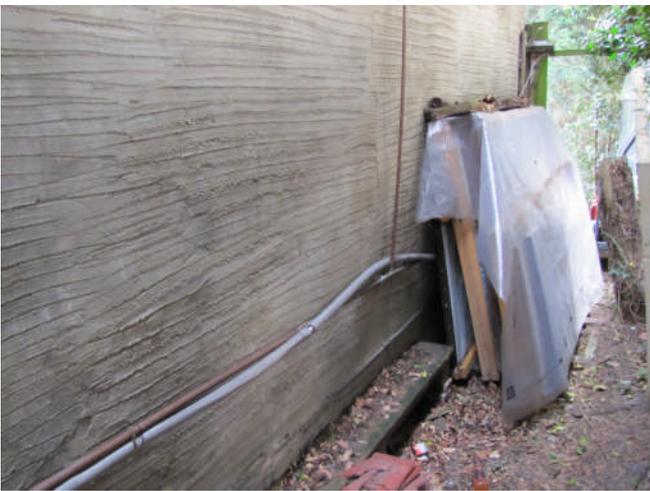
73. Scratch (first)-coat render to the right hand flank.

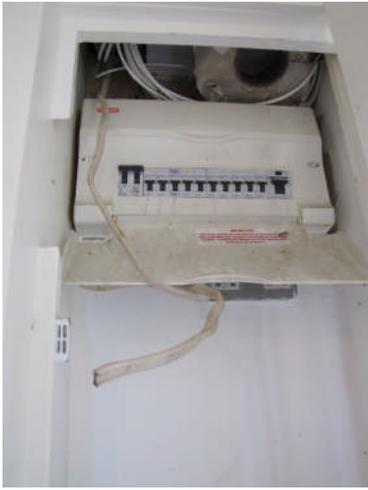
77. Consumer unit with a cable hanging in front.
